Full Scale Testing of Rock Bag Filter Units

Abstract

The use of rock bag type filter units for scour protection on revetments and in berth pockets are becoming more common around Australia. This is primarily driven by their ease of installation and ability to efficiently replace larger rock armour units, especially where there is limited supply. However, to date primarily only scale model testing of rock bag performance against propeller wash has been completed.

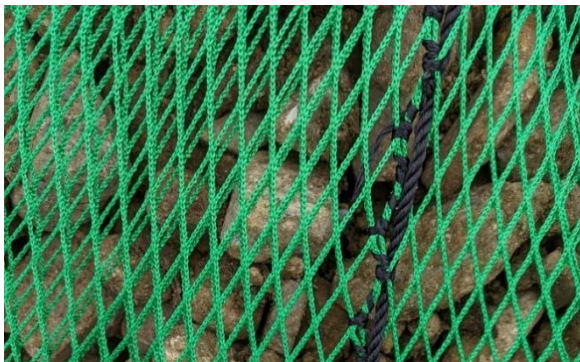
The small rock bags were made from a warp knitted, double mesh of a polyester and polyolefin blend as shown in Figure 2. The mesh construction resembles that of a trawl net, such that if a strand breaks and causes a hole it does not propagate easily throughout the bag.

Figure 2: Small rock bag mesh and rock size

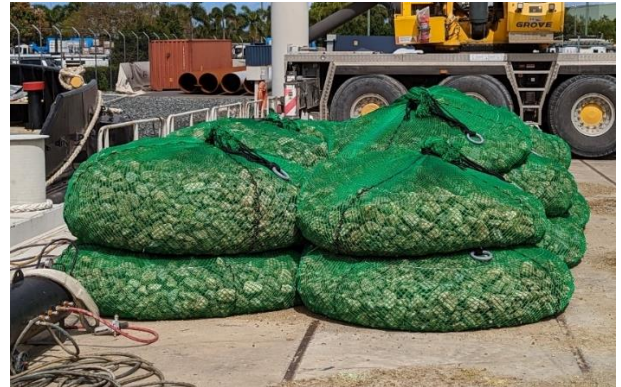
The rock bags were designed to be used with rounded river type stone which allows the bag to more easily conform in shape to the surrounding area as shown in Figure 3.

Figure 3: Small rock bag shape when stacked and filled to approximately 1.8 t

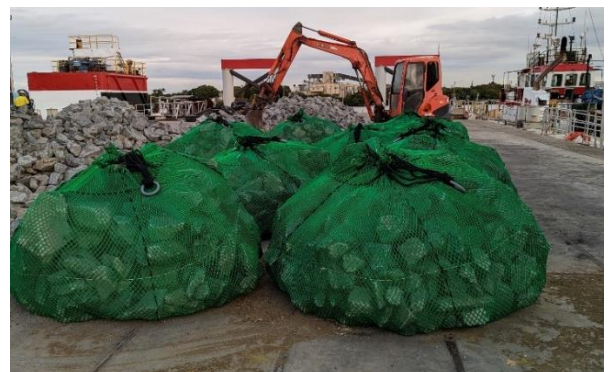
However, for the medium and large rock bags, larger quarry stone was used which increased the rock size and therefore reduced the roundness causing larger voids inside the bag as the rock could not easily move over each other. This also caused the bag to be slightly more rigid and not conform to the surrounding area as easily as the small bags as shown in Figure 4.

Figure 4: Medium rock bag prior to being placed in the water

- Use smaller rock in the medium and large rock bags to match the designer's specifications to allow the bag to settle more efficiently and replicate what would be typically installed
- Conduct the test in a less tidally impacted area to quantify the impact of different water levels and reduce the interference of tidal currents
- Test for more ASD offset distances to the rock bags
- Place additional water velocity sensors to the sides of the revetment to measure the flow parallel to the shoreline
- Utilise a larger vessel to provide greater water velocities and test to failure

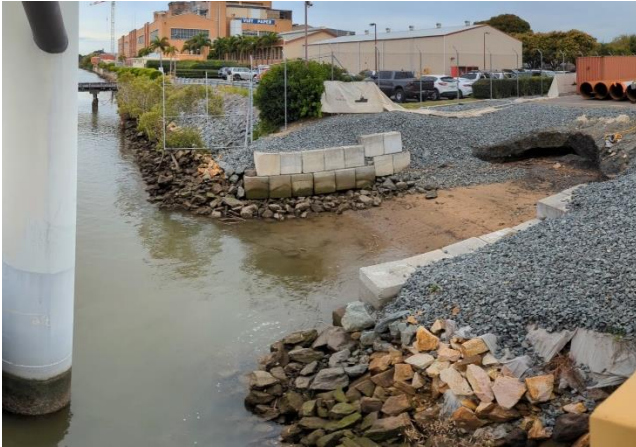
The tests were conducted at Pacific Tug's Brisbane Pacific Marine Base, located on the Brisbane River. The site featured a permanently moored barge, Coochie, suitable for loading and installing the rock bags onto the an existing damaged ramp via a mobile crane, as shown in Figure 5.

Figure 5: Original condition of test area

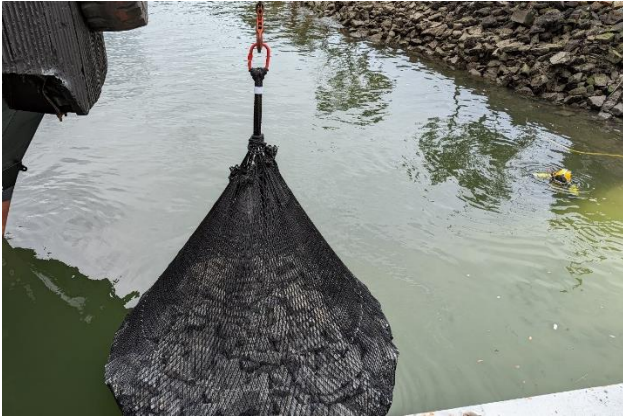
The rock bags were installed via a mobile crane and positioned via divers into the correct positions as shown in Figure 8. A bathymetric survey was conducted at several stages during the installation to ensure that the rock bags were installed in the correct location.

Figure 8: Photo of a large rock bag being craned into position with a diver on standby
